Manhole Inspection Summary

Manhole # S25I__040MH

Location Address: **Beside 1022 W.Lombard St.**

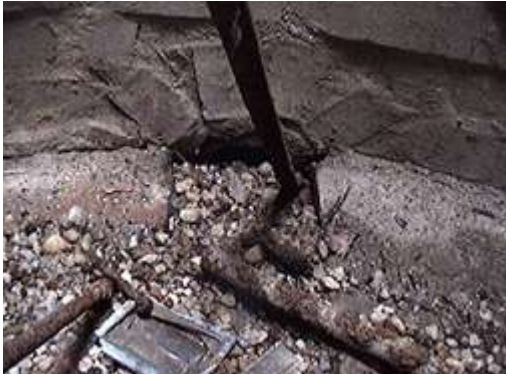
Defect 3

Comments **ABANDONED 9 O CLOCK SERVICE LINE FULL OF DEBRIS ALMOST NONE VISABLE, think this is more 68 than 40**

ABANDONED 9 O CLOCK SERVICE LINE. Channel and Bench Debris

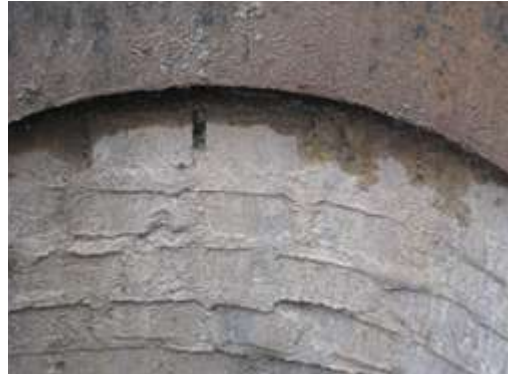
Defect 2

Infiltration: ☐ None ☐ Joint ☐ Cracks ☒ Mortar ☐ Roots ☐ Wall

MISSING MORTAR AT CHIMNEY WITH EVIDENCE OF INFILTRATION

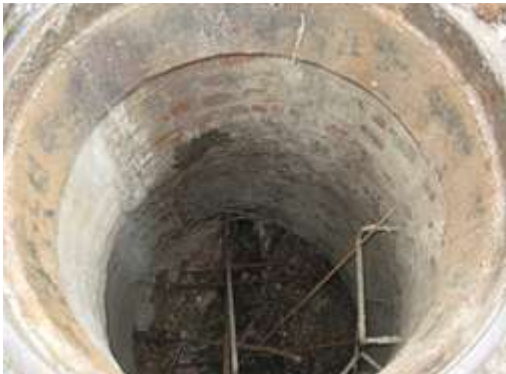
Defect 1

MUD DEPOSIT ON CORBEL

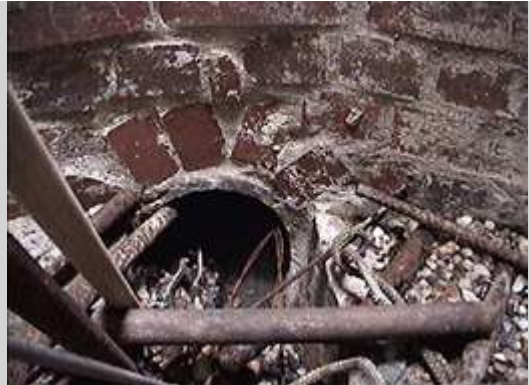
12 O'Clock Outflow

8 in. Circular Gravity Sewer
Pipe Out @ 12 O'Clock

Pipe Height: **8.4** (in.) Rod and Bar (Angled)
Pipe Material: **Clay** ☐ Pipe Lined
Invert Depth: **8.21** (ft.) Flow Characteristics: **None**
Deposits: ☒ None ☐ **Mud** ☐ Sludge ☐ **Debris** ☐ Grease
Silt Depth: **0** (in.) Deposits Extent:
Infiltration: **None** Pipe Seal Cond: **Unknown**

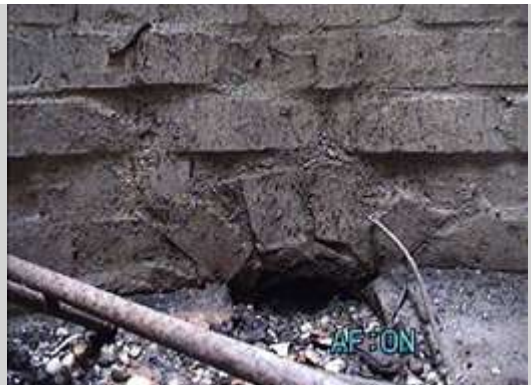
9 O'Clock Outflow

6 in. Circular Gravity Sewer
Pipe In @ 9 O'Clock

Pipe Height: **0** (in.) Direct
Pipe Material: **Clay** ☐ Pipe Lined
Invert Depth: **7.92** (ft.) Flow Characteristics: **None**
Deposits: ☐ None ☒ **Mud** ☐ Sludge ☒ **Debris** ☐ Grease
Silt Depth: **4** (in.) Deposits Extent: **Heavy**
Infiltration: **None** Pipe Seal Cond: **Unknown**
